FOUNDATION FAILURE

The Soft Soil Scaffolding Trap

LFI #001

Safety Moment: Analysis of a Structural Collapse

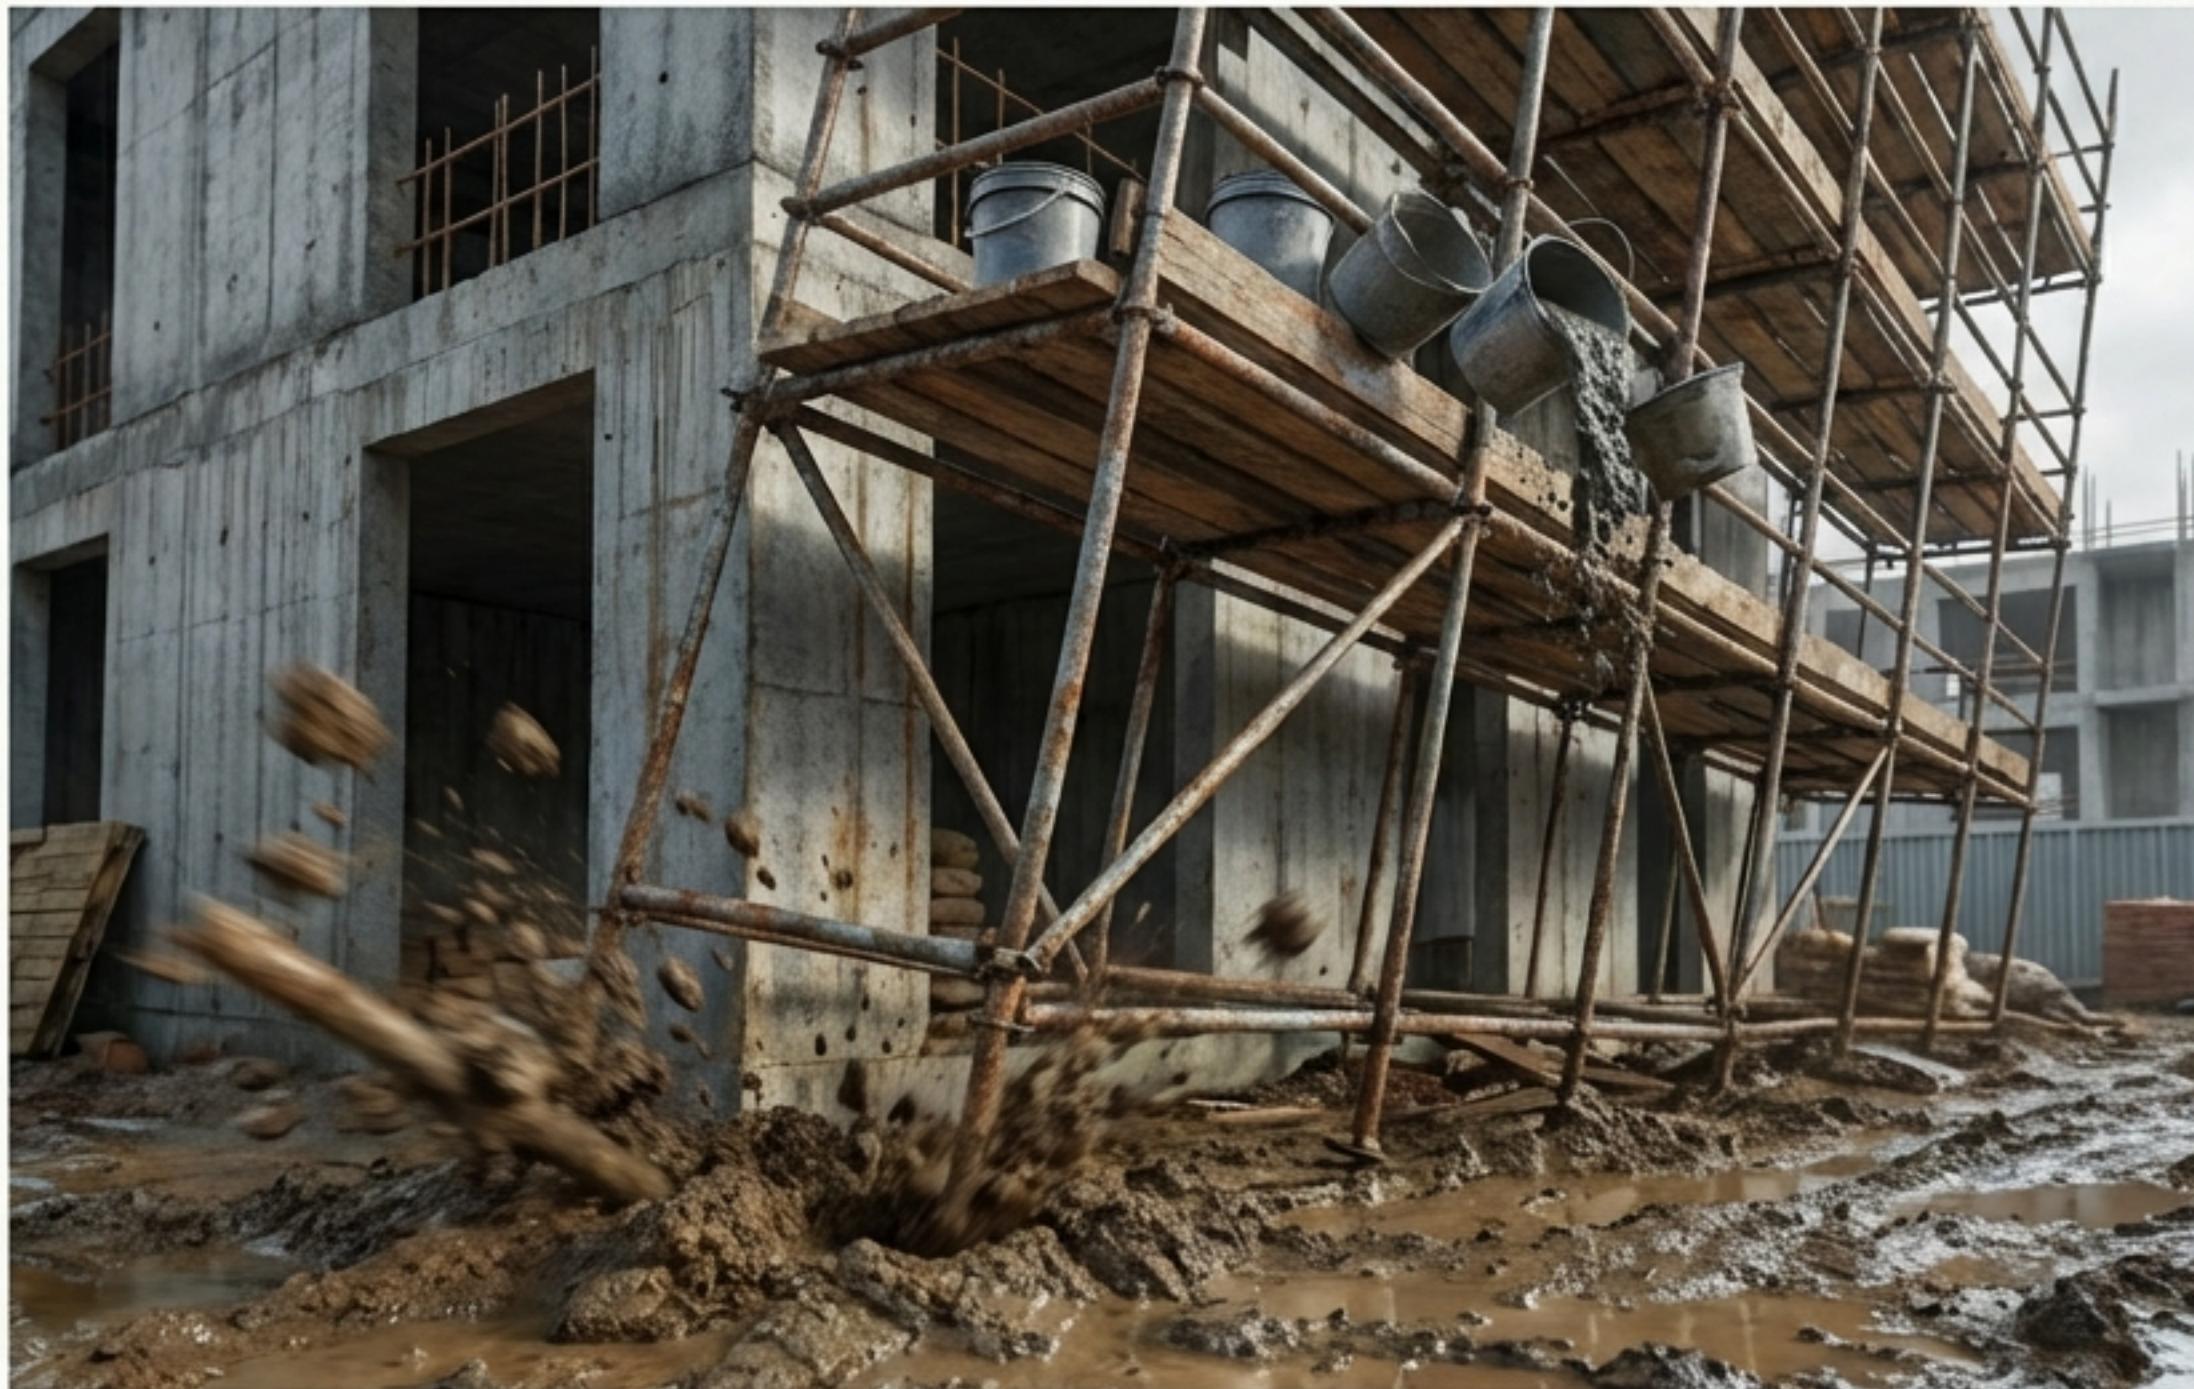
10:30 AM: THE COLLAPSE

Three workers climb the platform and load wet cement buckets.

The structure shifts suddenly under the added load.

Outer legs sink into softened soil. The scaffold tilts and collapses.

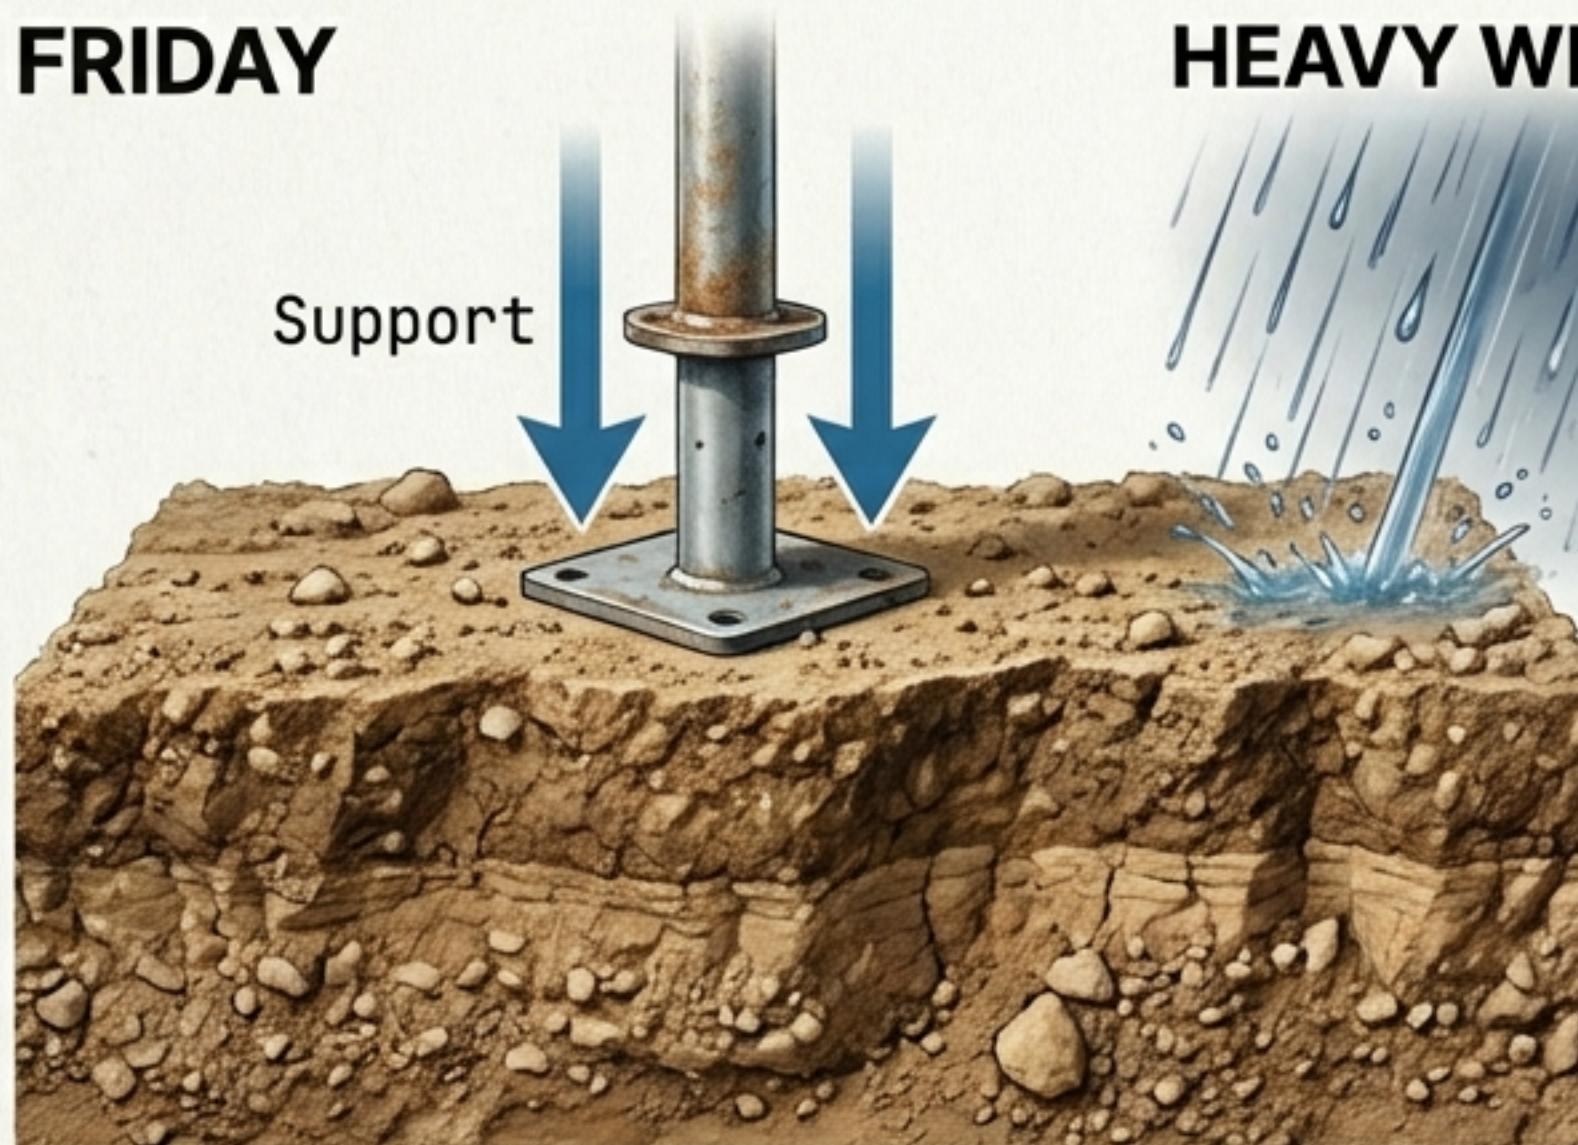
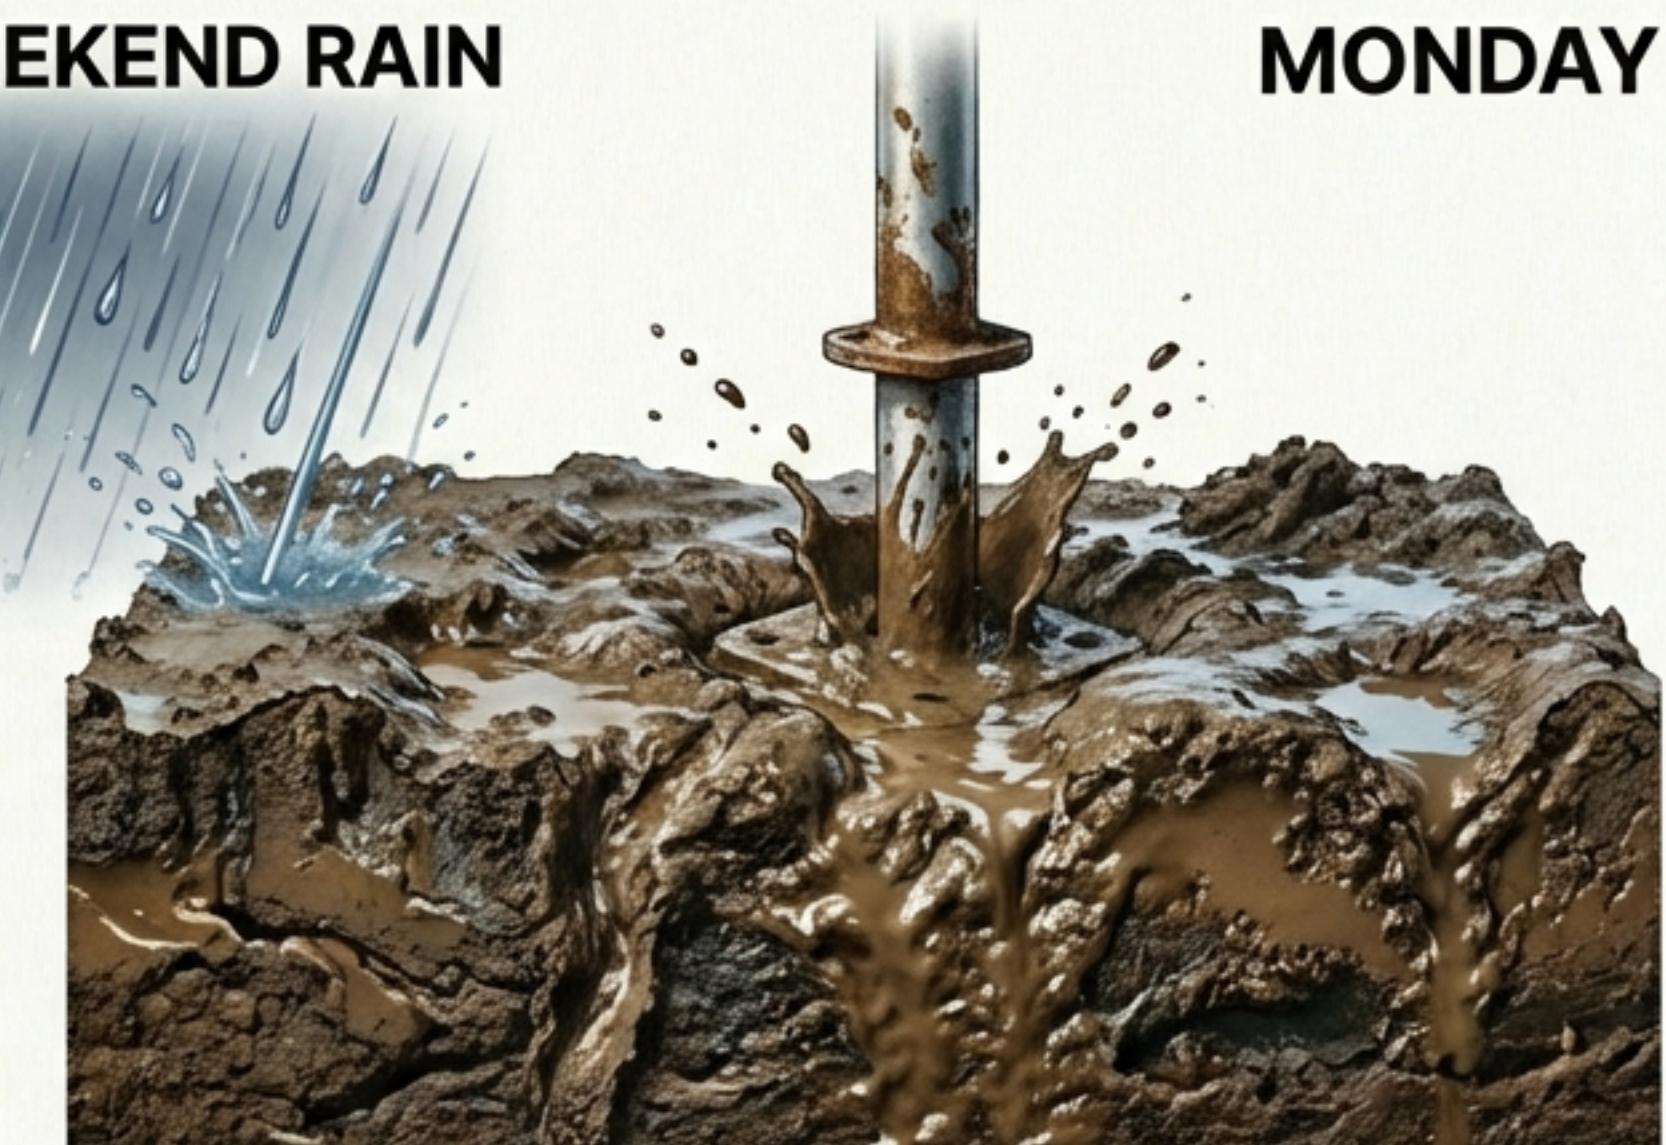
FACTOR 1: THE WEEKEND RAIN

EVENT: Heavy rain occurred over the weekend while the site was inactive.

IMPACT: The soil around the building perimeter transformed from solid ground into soft mud.

RESULT: The ground lost its load-bearing capacity. The 'floor' that existed on Friday was gone by Mon

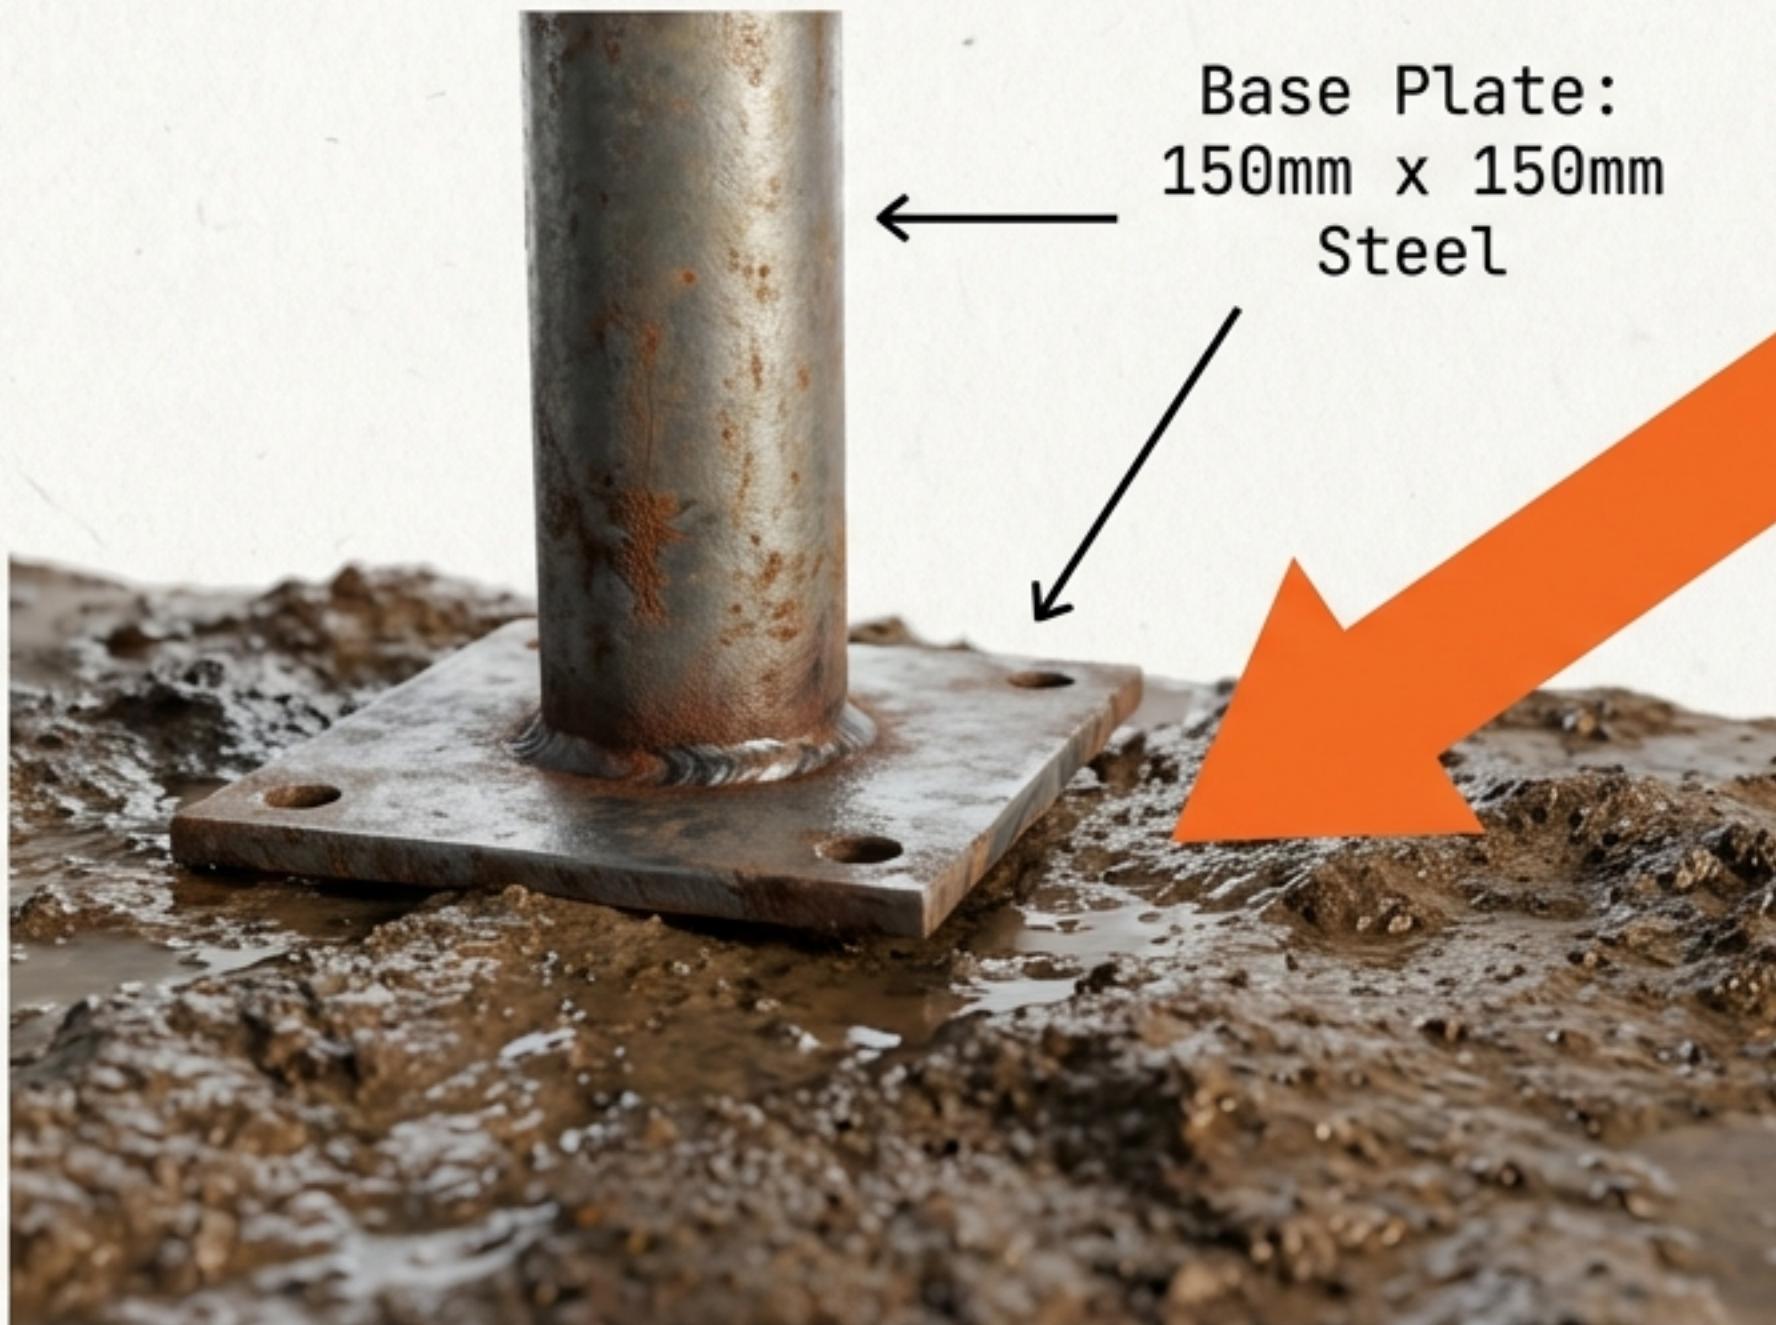
MISSING: WOODEN SOLE PLATE

THE SETUP: Scaffold standards rested on standard steel Base Plates.

THE ERROR: There were NO “Sole Plates” (wooden planks) used to distribute the load.

CONDITION: Steel was placed directly in contact with the soil.

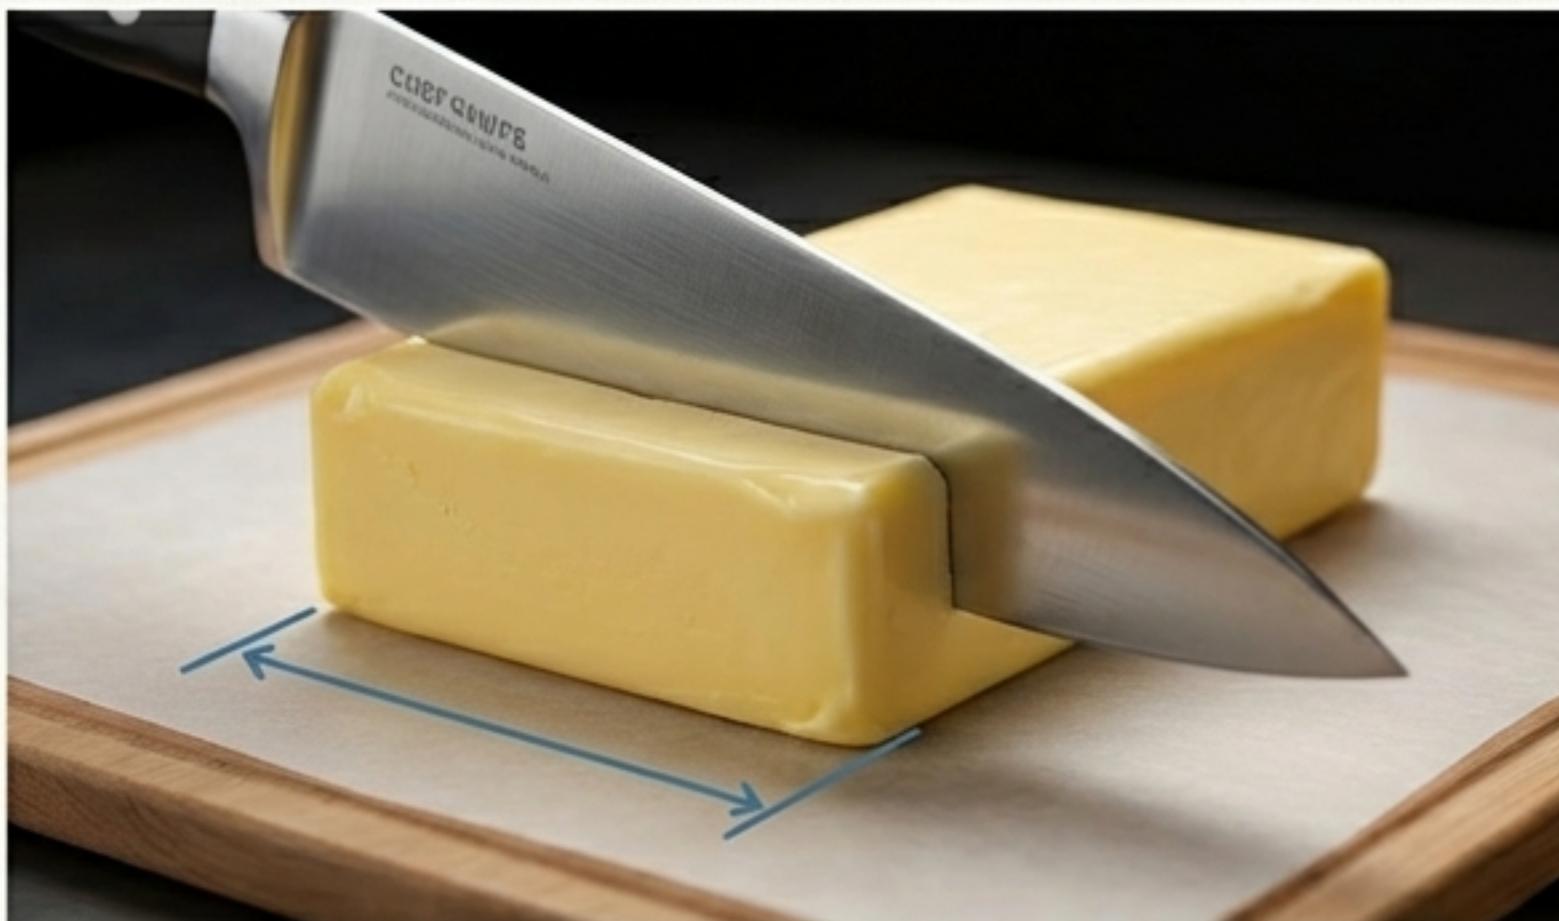
BASE PLATE ALONE (150mm)

(150mm x 1mm blade edge)

Concentrates force. Slices through soft material.

Without the wood to distribute the load, the steel plate had zero resistance against the softened n

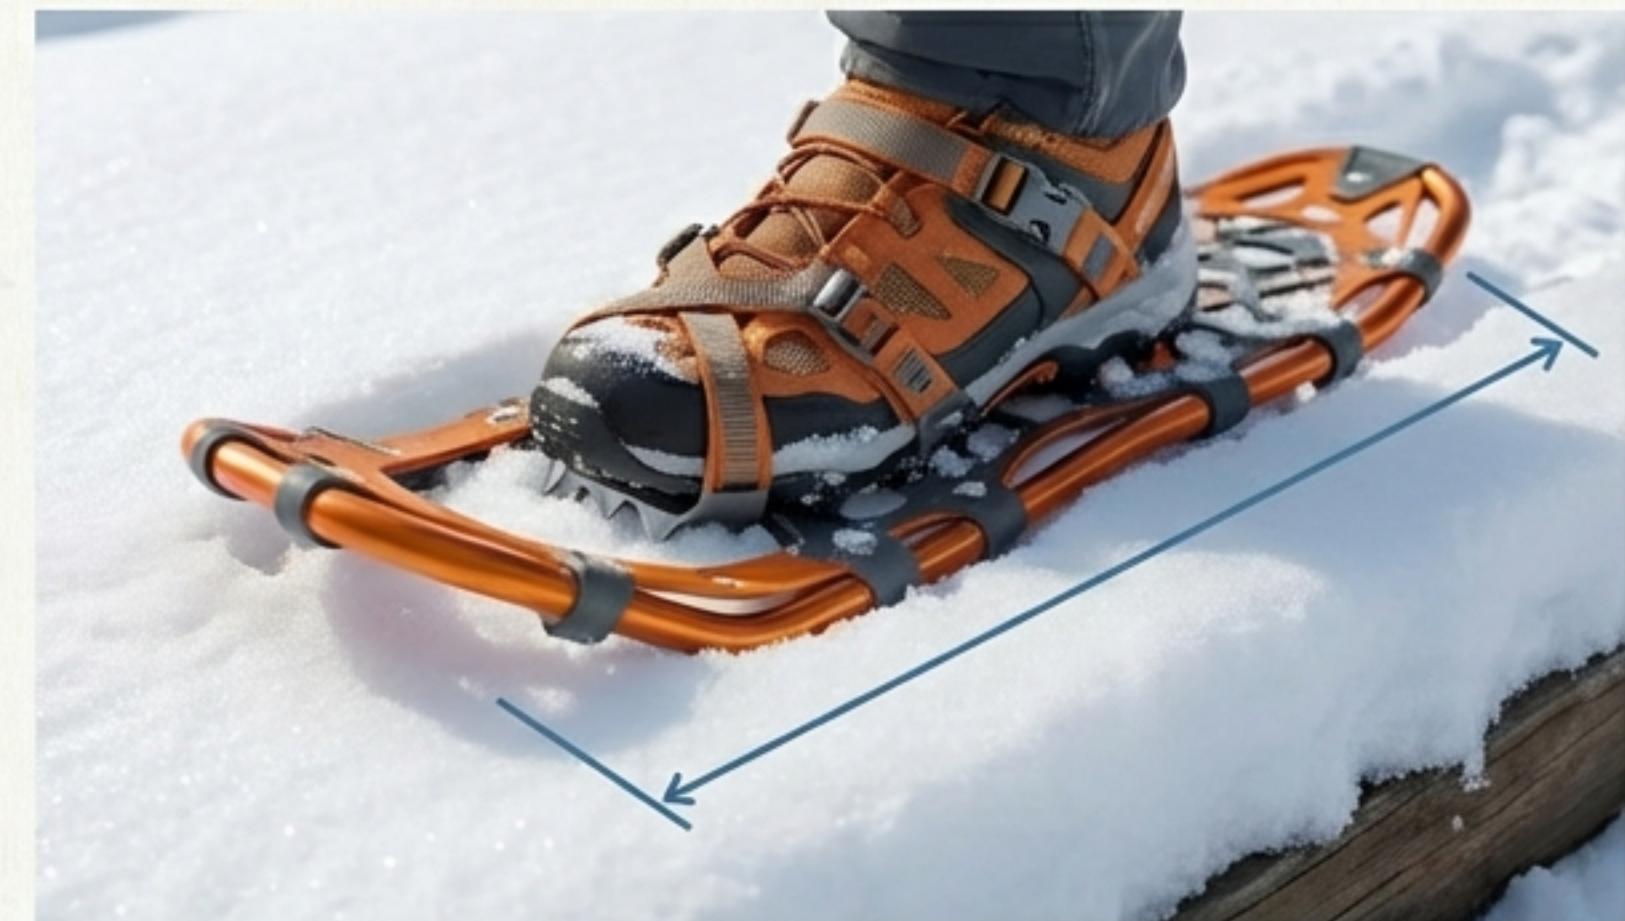
WITH SOLE PLATE (300mm+)

(300mm x 800mm snowshoe footprint)

Distributes force. Floats on soft material.

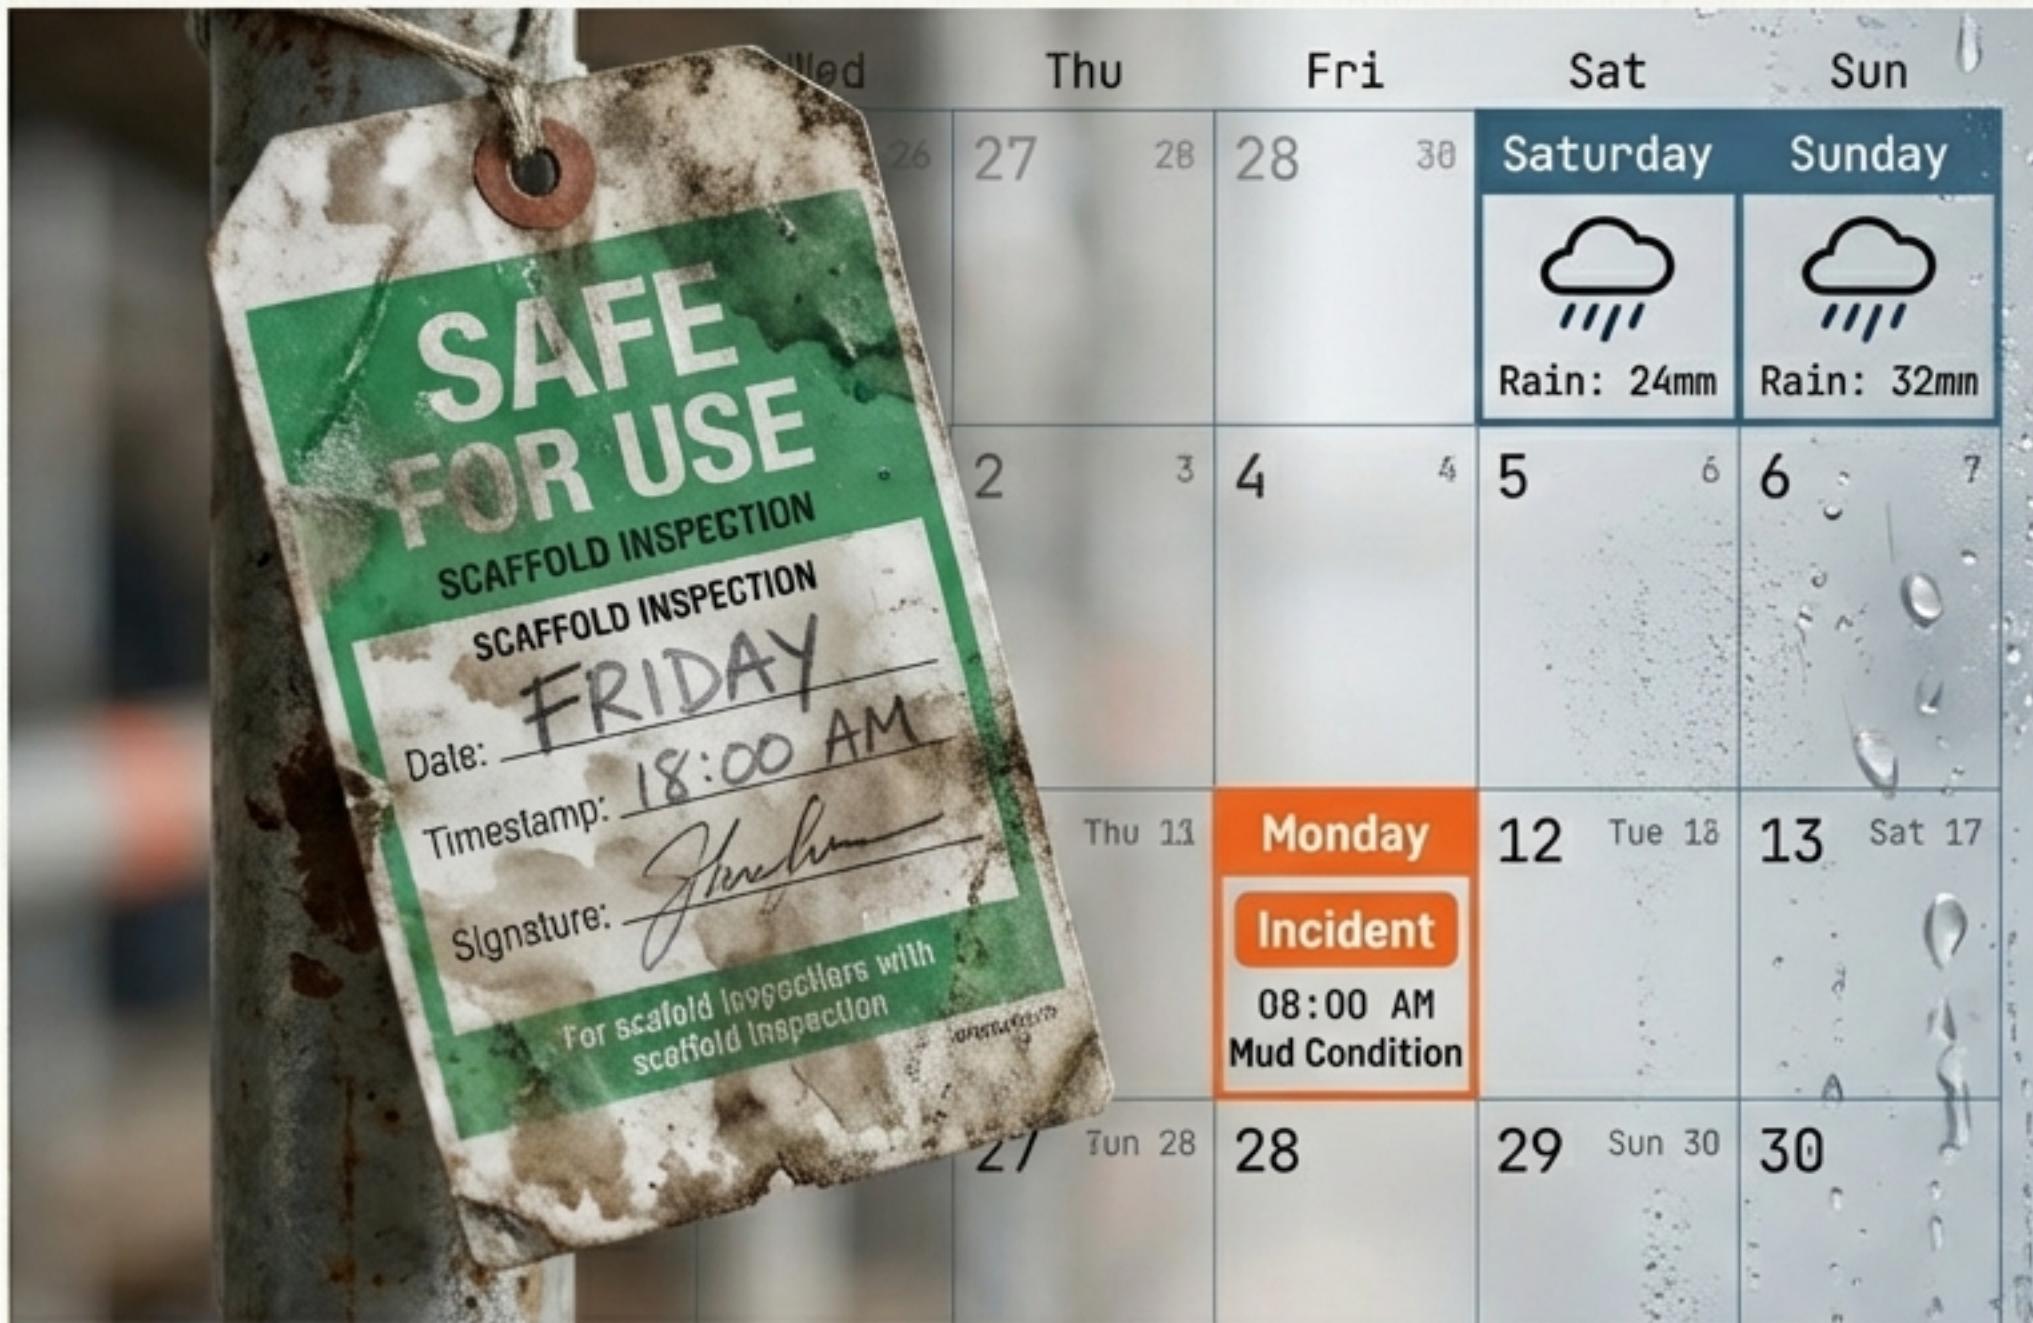
FACTOR 3: THE GREEN TAG TRAP

Supervisor trusted Friday's tag on Monday's mud.

A tag is a snapshot in time, not a guarantee.

IS 3696 mandates re-inspection after bad weather. No one checked the base conditions before work began.
