FOUNDATION FAILURE

The Soft Soil Scaffolding Trap

LFI #001

Safety Moment: Analysis of a Structural Collapse

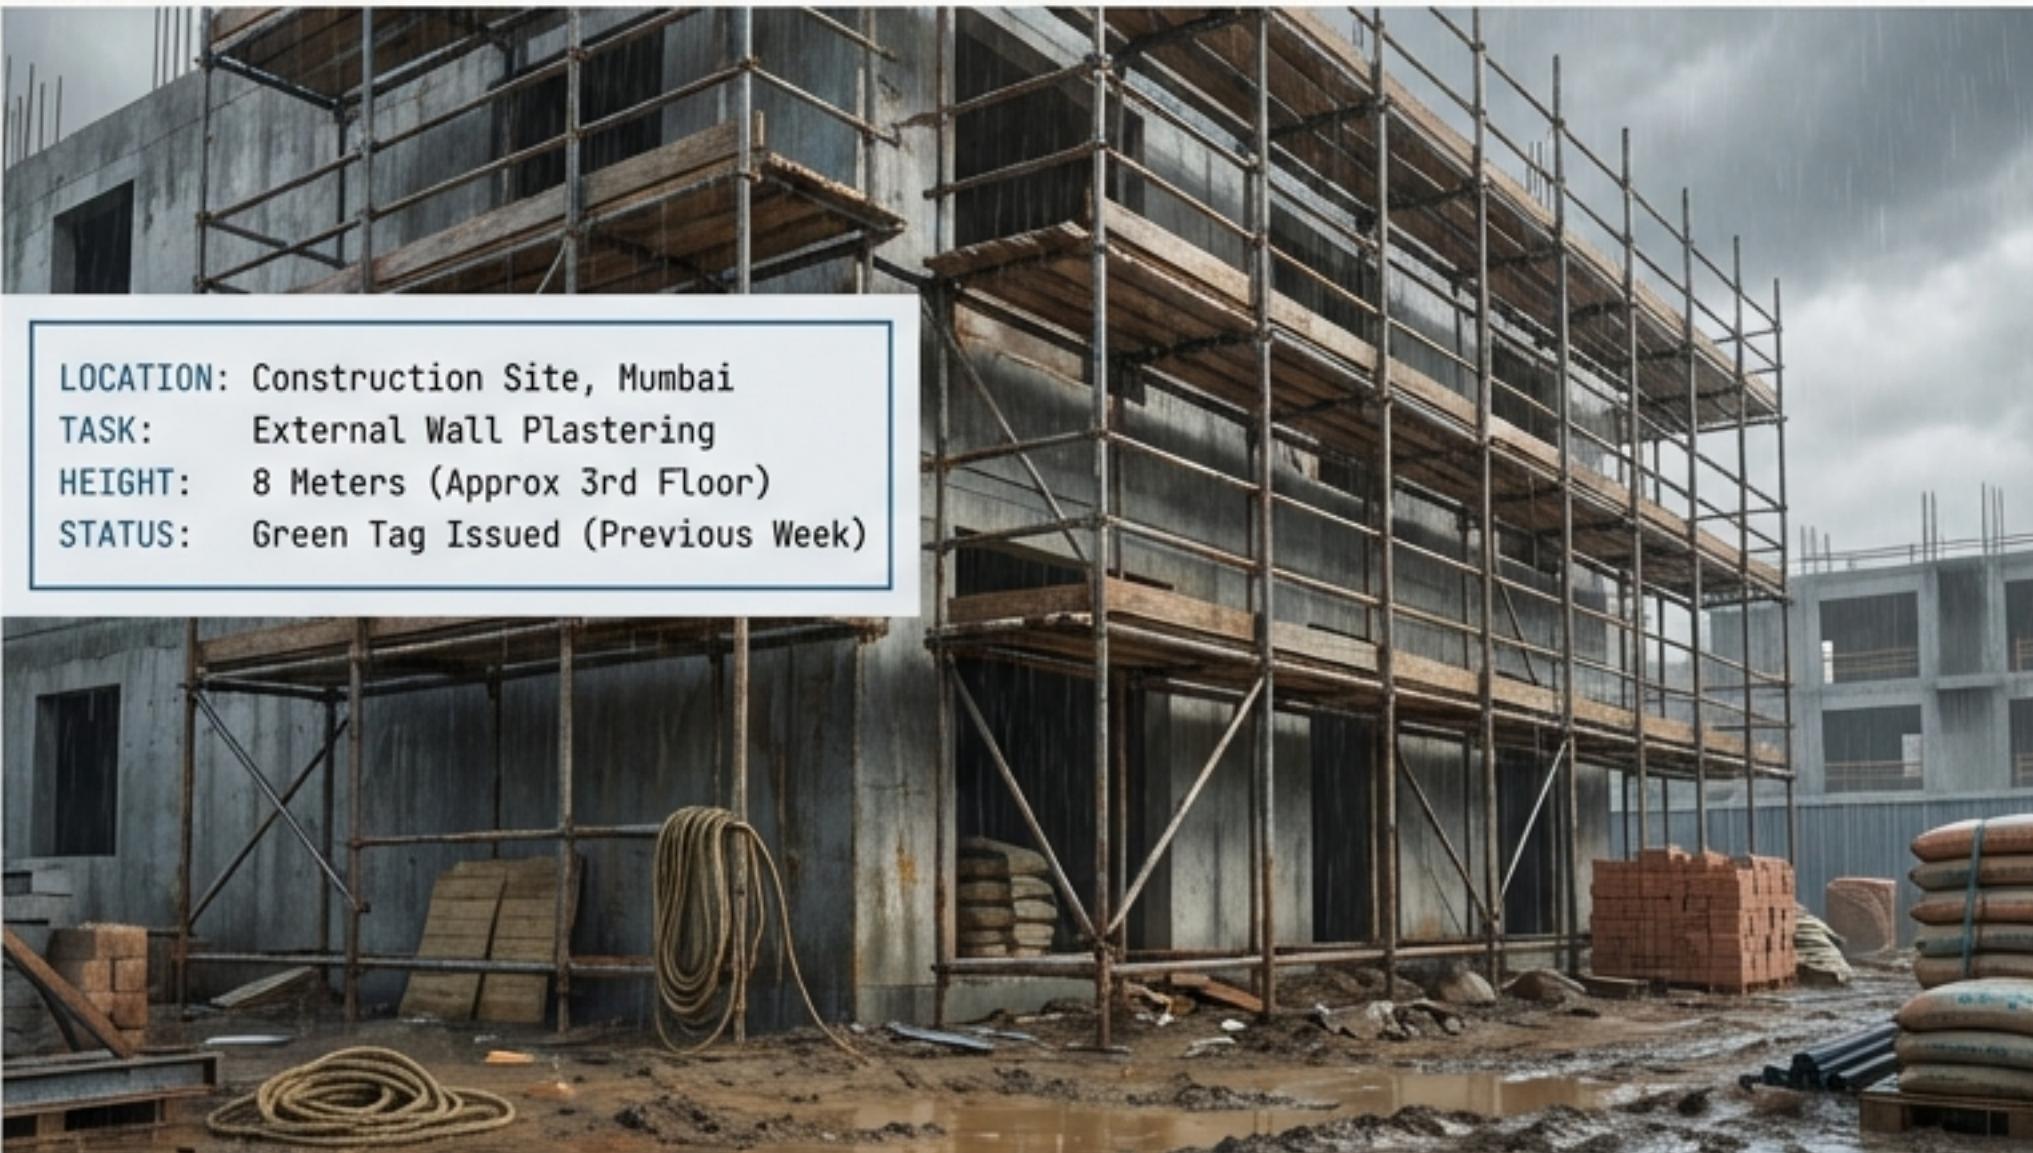
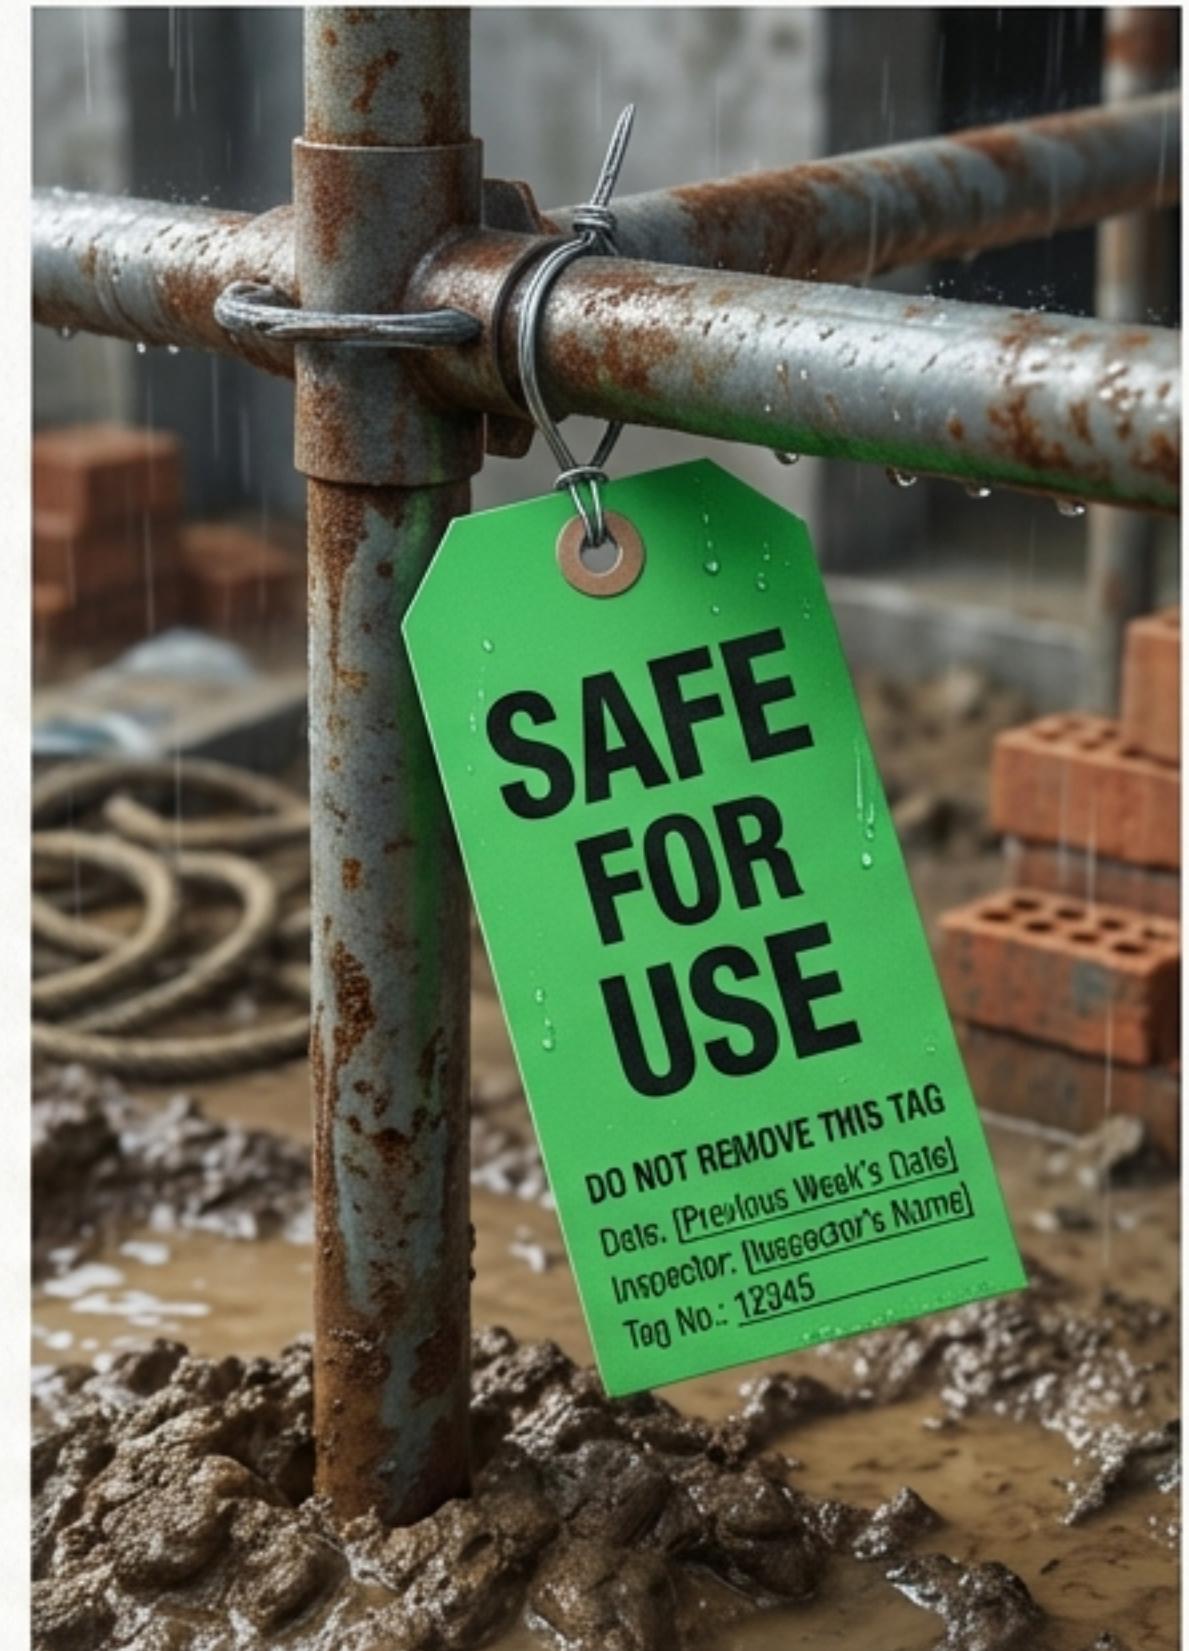
MONDAY MORNING. 8 METERS HIGH. TAGGED 'SAFE'.

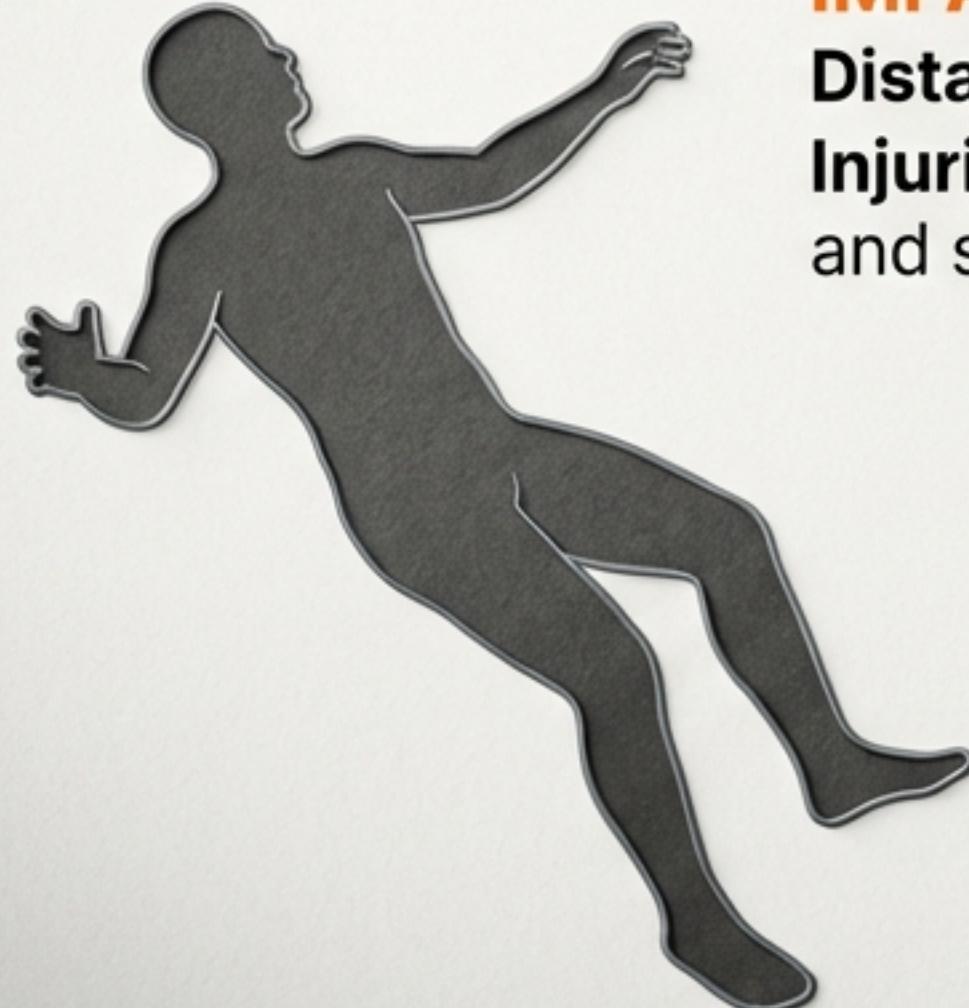
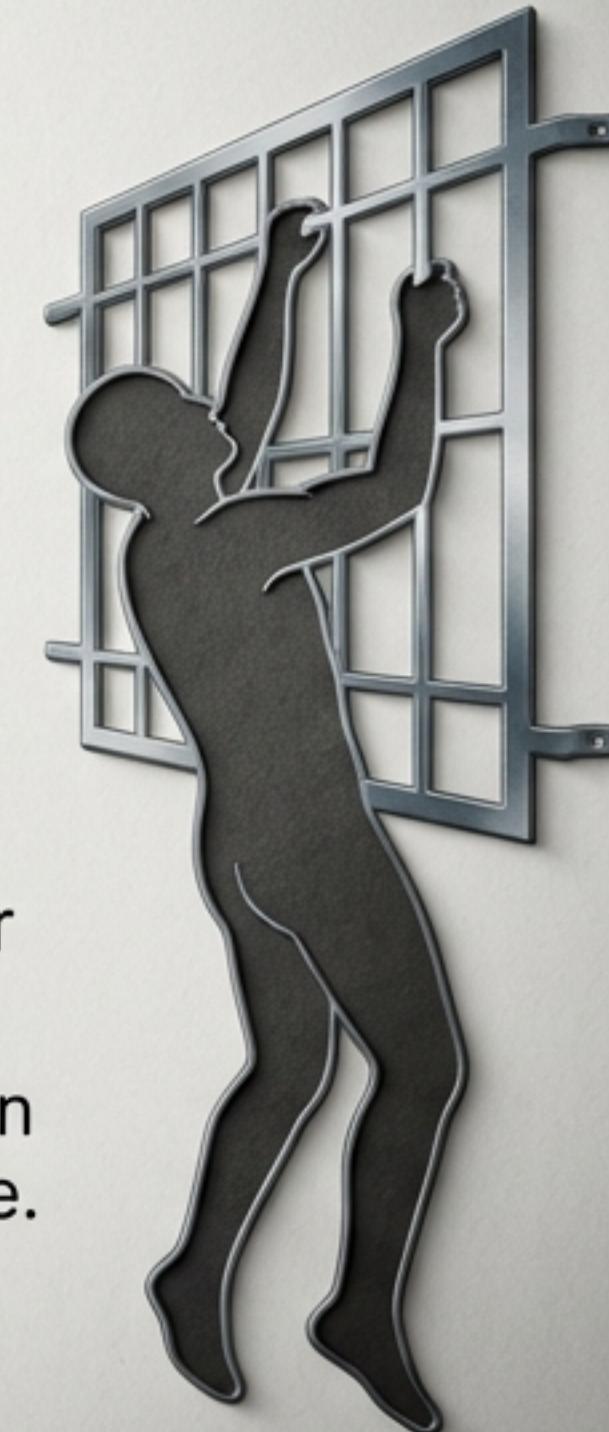
8 Meters

IMPACT: 2 Workers
Distance: 8 Meter Fall
Injuries: Multiple fractures and spinal injury.

SUSPENSION: 1 Worker
Duration: 20 Minutes
Outcome: Left hanging on a window grill until rescue.
